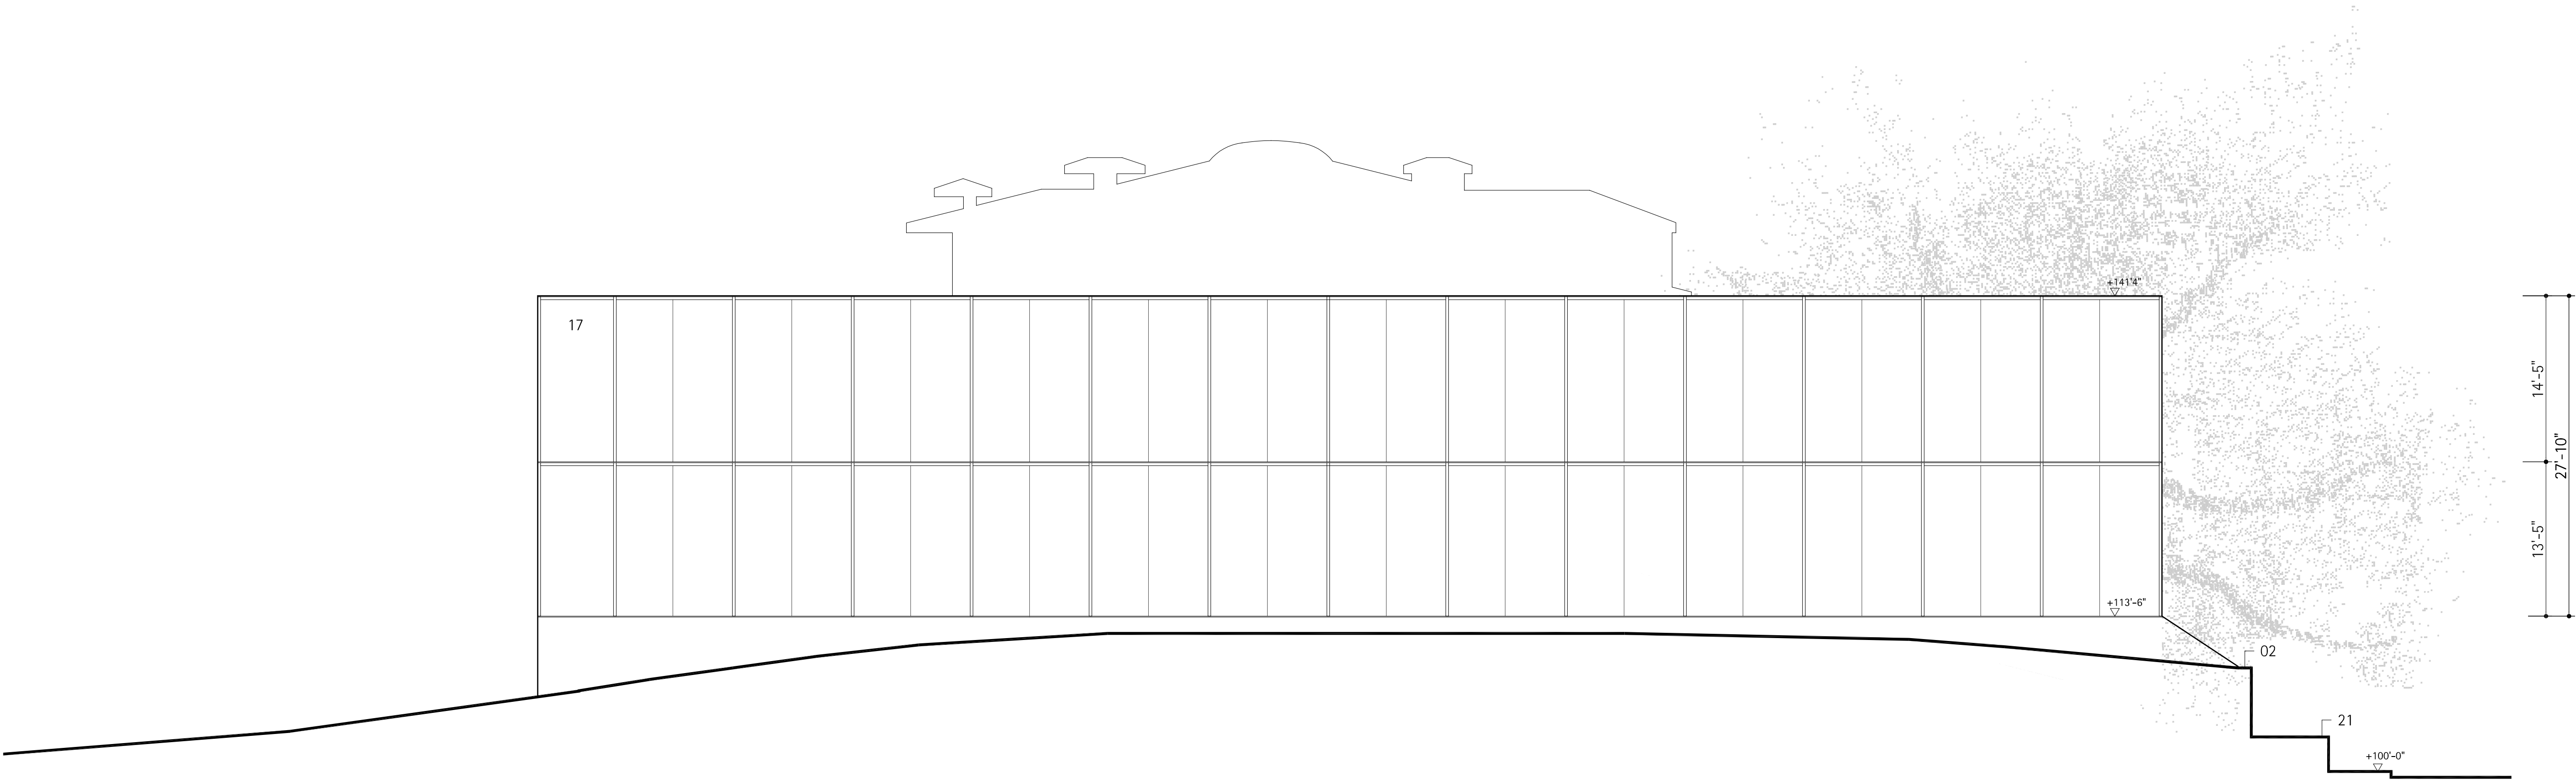
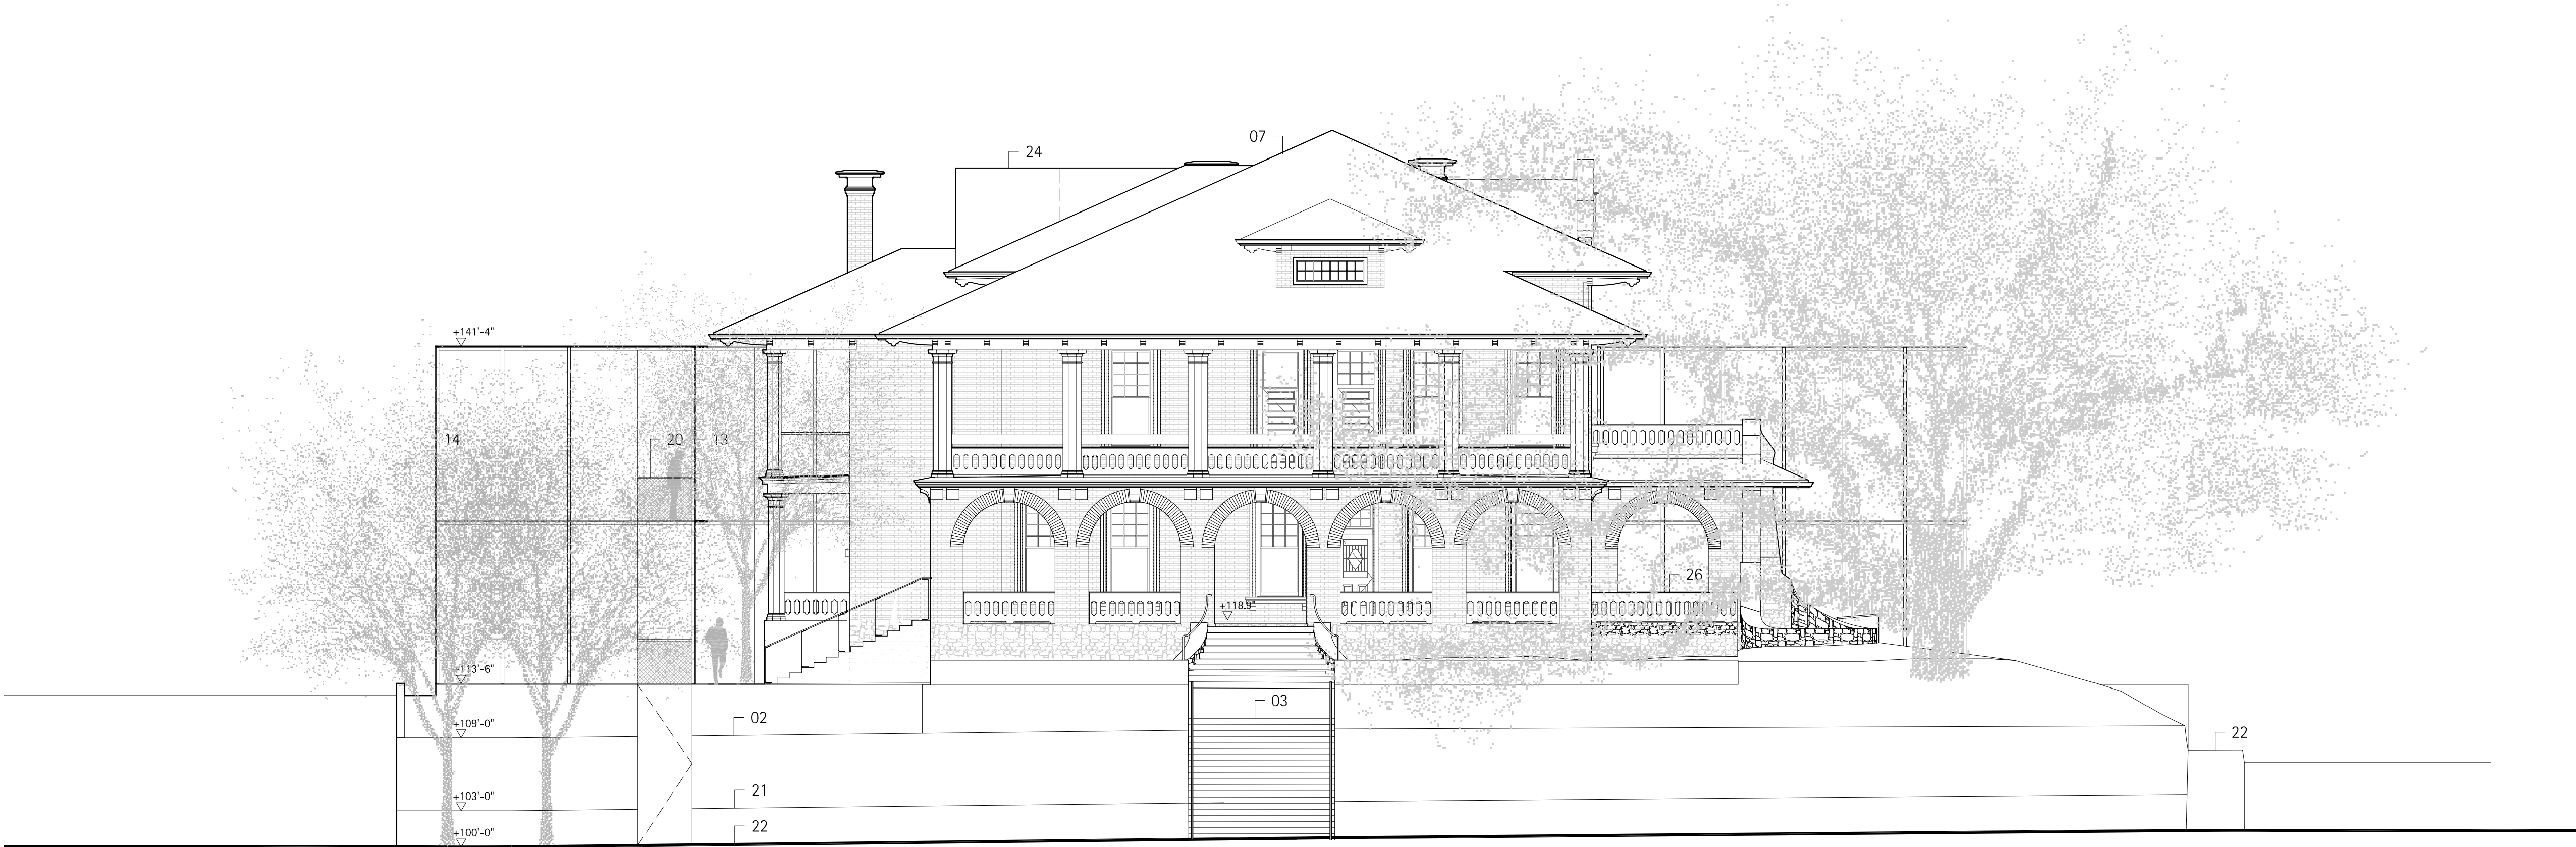
- See Sheet A003 for Master Notes
- 01 New Concrete Foundation Wall
 - 02 Existing Historic Site Wall to be Refurbished.
 - 03 Existing Stairs to be Replaced with Code Compliant Stair with Solid Granite Block

- 04 Entrance to New Addition at Nueces Street
 - 05 Historic Trees to Remain
 - 06 New Trees
 - 07 Historic Structure, See "H" Drawings for more Info.
 - 08 Existing Pathway to be Removed and Replaced with Burnished Concrete

- 09 New Limestone Stair with New Stainless Steel Handrail
 - 10 Existing Limit of Roof Eave
 - 11 New White Painted Metal Panel Site Wall Sub-Structure to be 2Hr Rated Wall

- 12 Insulated Metal Panel on Concrete Elevator Shaft
 - 13 Painted Steel Structure
 - 14 Insulated Glass Unit Window System
 - 15 Insulated Glass Unit Door System

- 16 Raised Floor on Exposed Steel Framing
 - 17 White Painted Metal Panel on Steel Stud Framing
 - 18 Painted, Tread and Riser, Stair
 - 19 Fully Adhrered PVC Roof Membrane

- 20 Stainless Steel Wire Mesh Guardrail
 - 21 New Site Retaining Wall
 - 22 New Sidewalk
 - 23 New ADA Ramp
 - 24 Elevator Bulk Head
 - 25 ADA Platform Lift

- 26 New Historic Balustrade

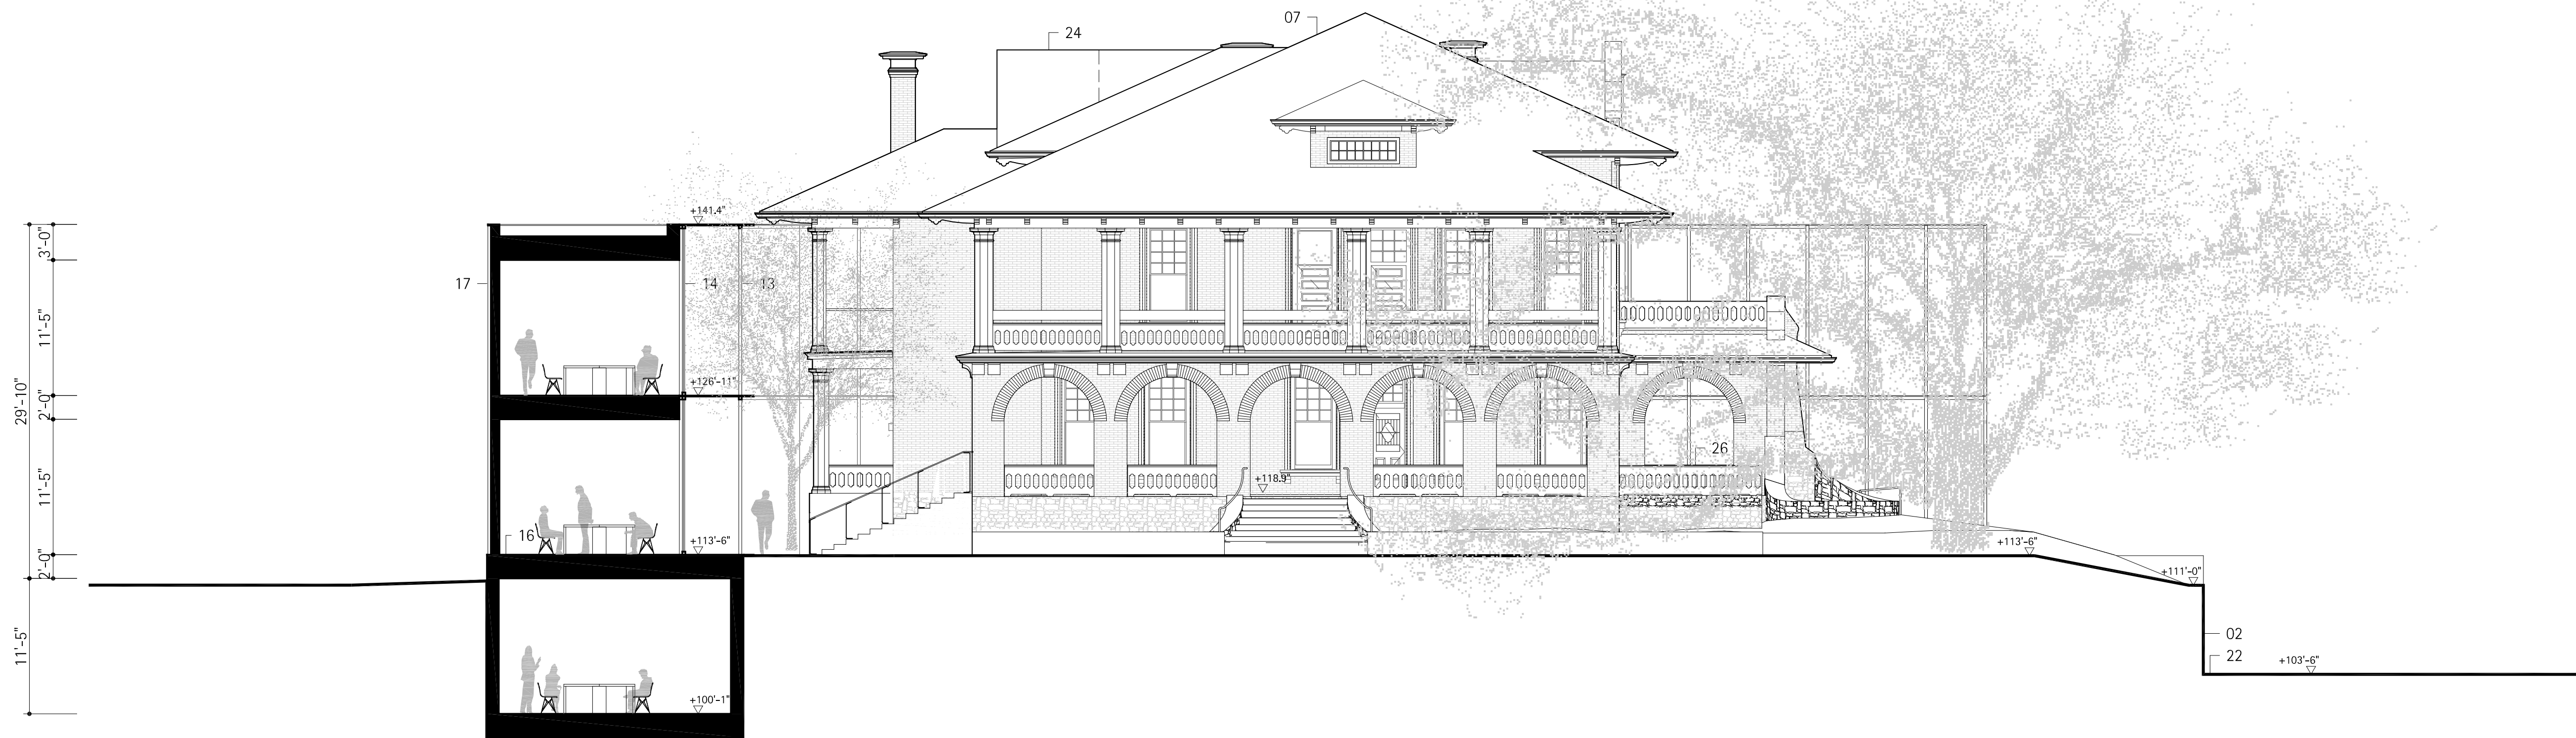
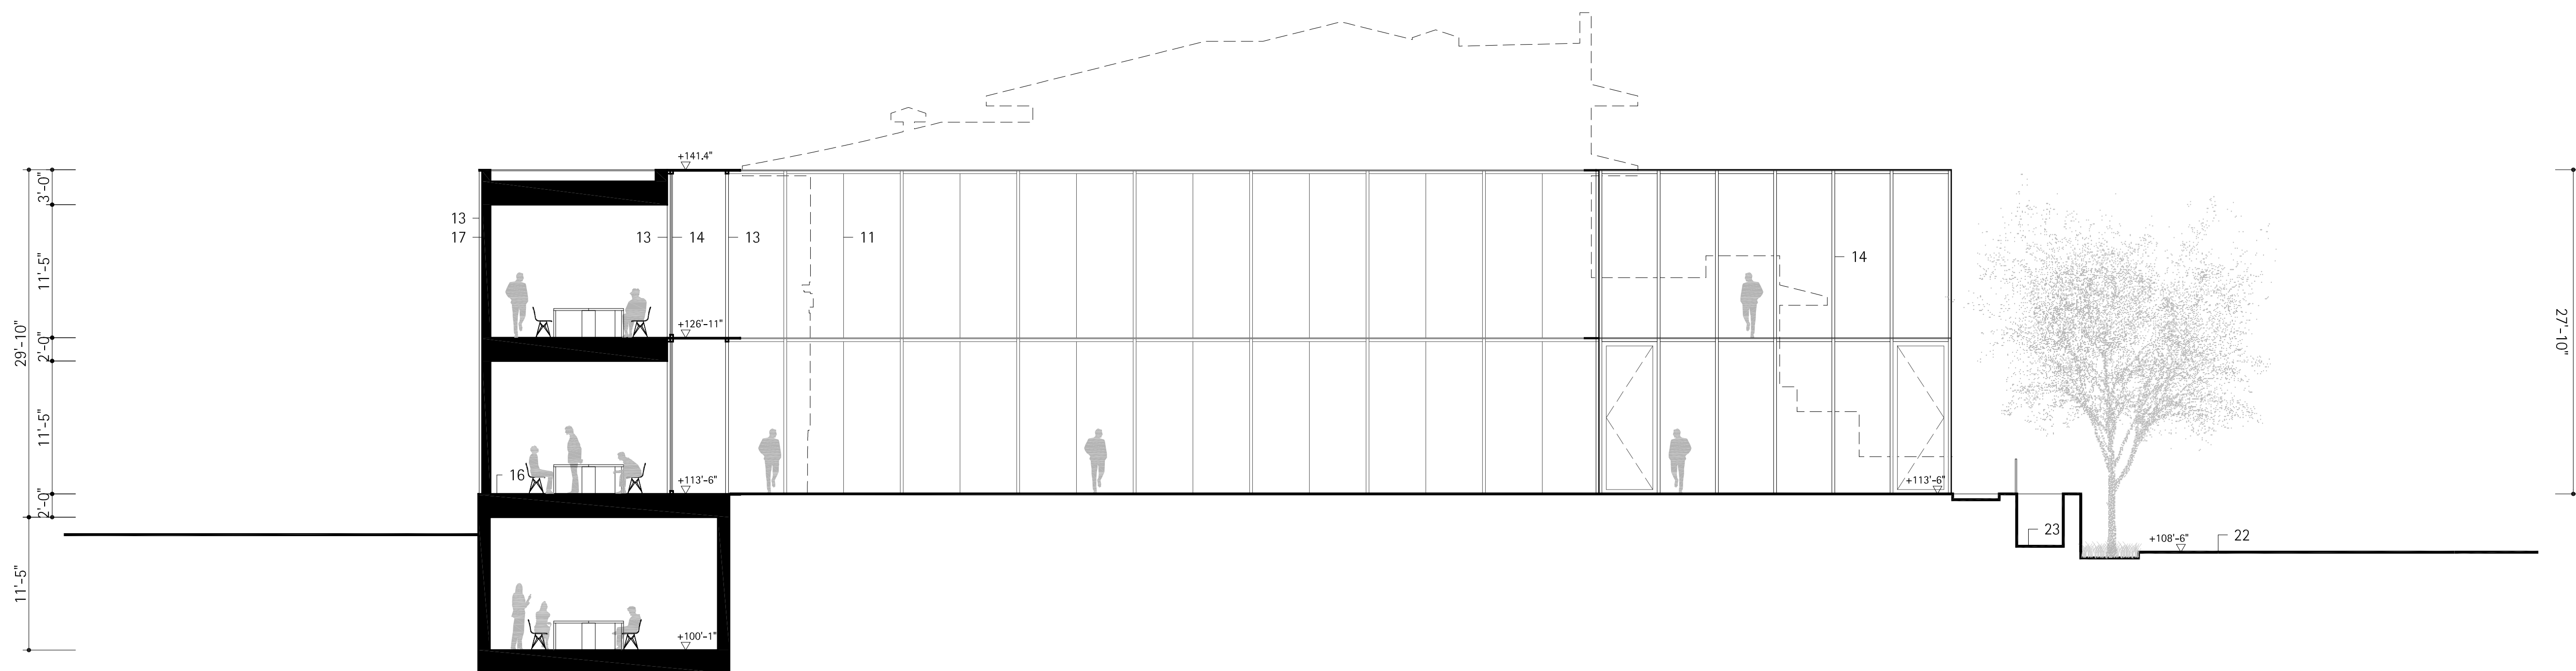
| 01 | New Concrete Foundation Wall |
| 02 | Existing Historic Site Wall to be Refurbished. |
| 03 | Existing Stairs to be Replaced with Code Compliant Stair with Solid Granite Block |
| 04 | Entrance to New Addition at Nueces Street |
| 05 | Historic Trees to Remain |
| 06 | New Trees |
| 07 | Historic Structure, See "H" Drawings for more Info. |
| 08 | Existing Pathway to be Removed and Replaced with Burnished Concrete |
| 09 | New Limestone Stair with New Stainless Steel Handrail |
| 10 | Existing Limit of Roof Eave |
| 11 | New White Painted Metal Panel Site Wall Sub-Structure to be 2Hr Rated Wall |
| 12 | Insulated Metal Panel on Concrete Elevator Shaft |
| 13 | Painted Steel Structure |
| 14 | Insulated Glass Unit Window System |
| 15 | Insulated Glass Unit Door System |
| 16 | Raised Floor on Exposed Steel Framing |
| 17 | White Painted Metal Panel on Steel Stud Framing |
| 18 | Painted, Tread and Riser, Stair |
| 19 | Fully Adhered PVC Roof Membrane |
| 20 | Stainless Steel Wire Mesh Guardrail |
| 21 | New Site Retaining Wall |
| 22 | New Sidewalk |
| 23 | New ADA Ramp |
| 24 | Elevator Bulk Head |
| 25 | ADA Platform Lift |
| 26 | New Historic Balustrade |
